DOT/FAA/AR-95/51

Nondestructive Inspection of Piper PA-25 Forward Spar Fuselage Attachment Fitting

September 1995

Final Report

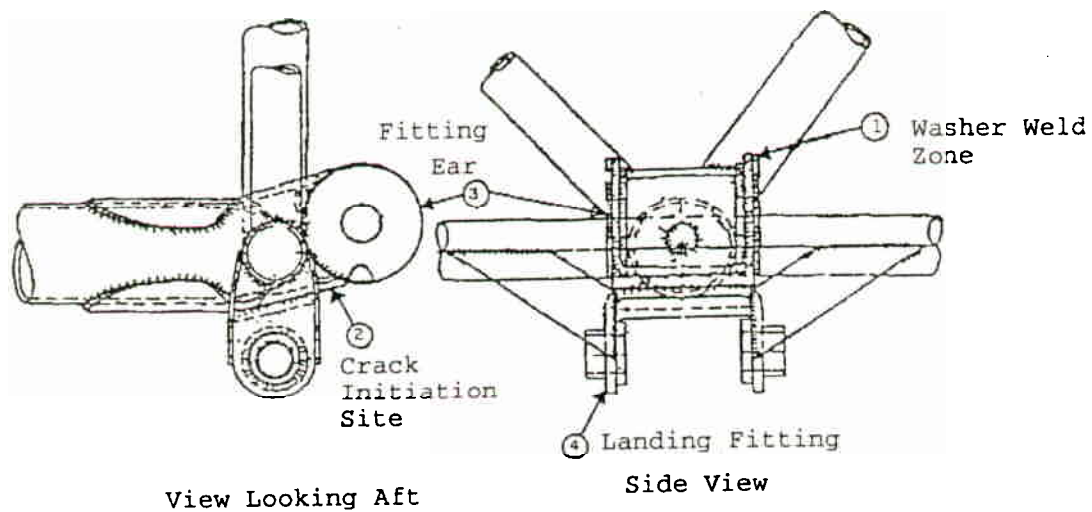
On May 21, 1993, an in-flight separation of the wing from a Piper PA-25 airplane occurred. The investigation of the affected airplane revealed corrosion and cracks in the forward spar fuselage attachment fittings. The forward spar fuselage attachment fitting consists of a clevis ear welded to a 4130 steel tube forward spar as illustrated in figures 1 and 2. This welded metal interface fractured at the base of the clevis ear. Extensive corrosion was found at the fracture site. Further review revealed that a strong oxidation layer between the two welded sections of the fitting assembly (washer and ear flange) had occurred over a long period of time. Figures 3 and 4 are photographs showing the corroded spar fuselage attachment. This airplane was used for agricultural crop dusting and had accumulated over 5,000 hours time in service (TIS) at the time of the accident. A similar accident had occurred previously on September 21, 1991, to an airplane with 10,000 hours TIS. These two different accidents alerted the FAA that an unsafe condition may exist on the Piper Model PA-25. The FAA also believes that airplanes utilized in agricultural environments are extremely susceptible to the above corrosion conditions.

FIGURE 1. VIEW LOOKING AFT AND A SIDE VIEW OF THE SPAR ATTACHMENT FITTING FOR THE PIPER MODEL PA-25-150. FIGURE WAS TAKEN FROM AD 93-21-12.

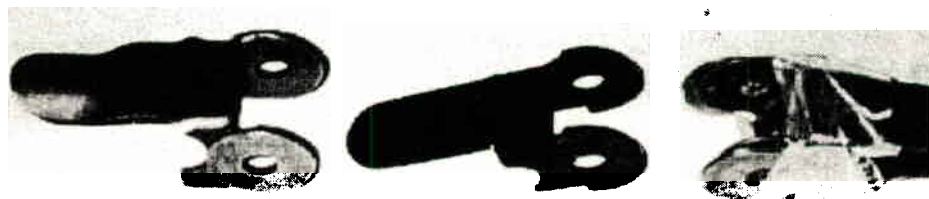
On March 4, 1994, two forward attachment spar clusters and a new Piper manufactured fitting were received from the Atlanta ACO. Sample 1 was a new, fully assembled ear fitting. To help understand the current welding process, two subassembly piece parts were also sent (figure 5). Sample 2 was a forward spar fuselage attachment cluster which had extensive pitting and surface

FIGURE 5. SAMPLE 1 - A NEW, FULLY ASSEMBLED EAR FITTING (FAR LEFT) AND TWO SUBASSEMBLY PARTS.

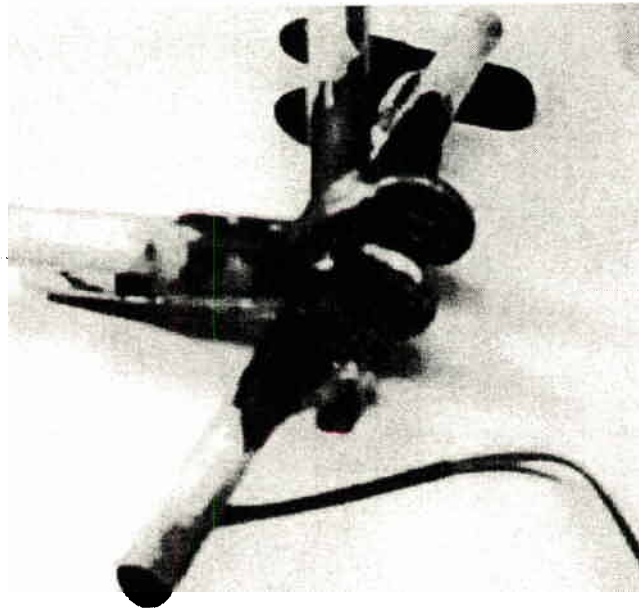
corrosion on both ear fittings. Half of one ear was removed by a bandsaw to reveal the inner layer corrosion shown in figure 6. Sample 3 was a forward spar fuselage attachment cluster used as a blind sample to develop the inspection techniques. It was not known if corrosion existed between the inner layers. Sample 3 is shown in figure 7. The AANC staff performed both radiography and ultrasonic inspections on the spar cluster assembly. Test setup, calibration, and inspection techniques are described, and findings from each technique are stated.

FIGURE 7. SAMPLE 3 - BLIND SAMPLE USED TO DEVELOP THE INSPECTION TECHNIQUES.

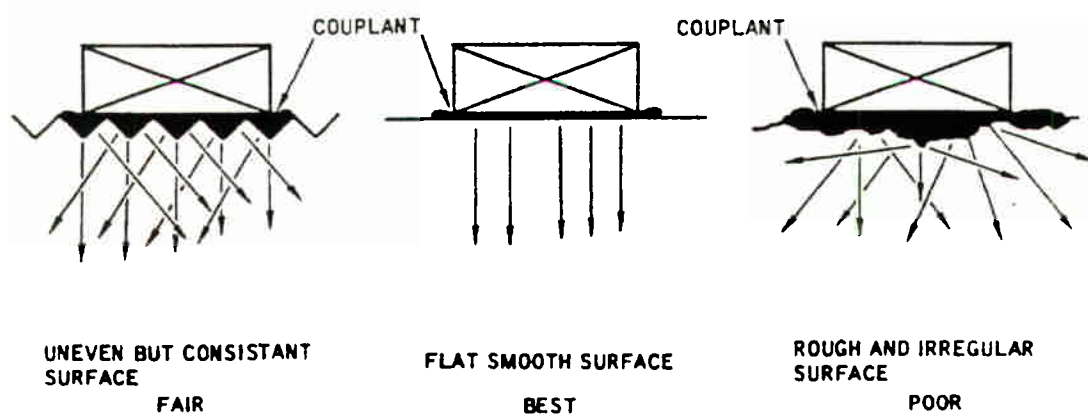
The test setup was then applied on the surface corroded sample 2. The thickness of sample 2 could not be determined. The instrument sensitivity (gain) was increased and the backwall echo still could not be detected. The problems with sample 2 were due to the rough outer surface of the test sample. Figure 11 illustrates the undesirable effect of surface roughness on the distortion of ultrasonic wave propagation. This probe and technique were abandoned.

FIGURE 11. ILLUSTRATION OF THE UNDESIRABLE EFFECT OF DISTORTION OF WAVE DIRECTIVITY DUE TO THE SURFACE OF THE TEST SPECIMEN AND HOW IT CAN GREATLY AFFECT ULTRASONIC WAVE PROPAGATION.
